WAUBEEKA LAKE DAM

CT 00065

PHASE I INSPECTION REPORT

JULY 1981

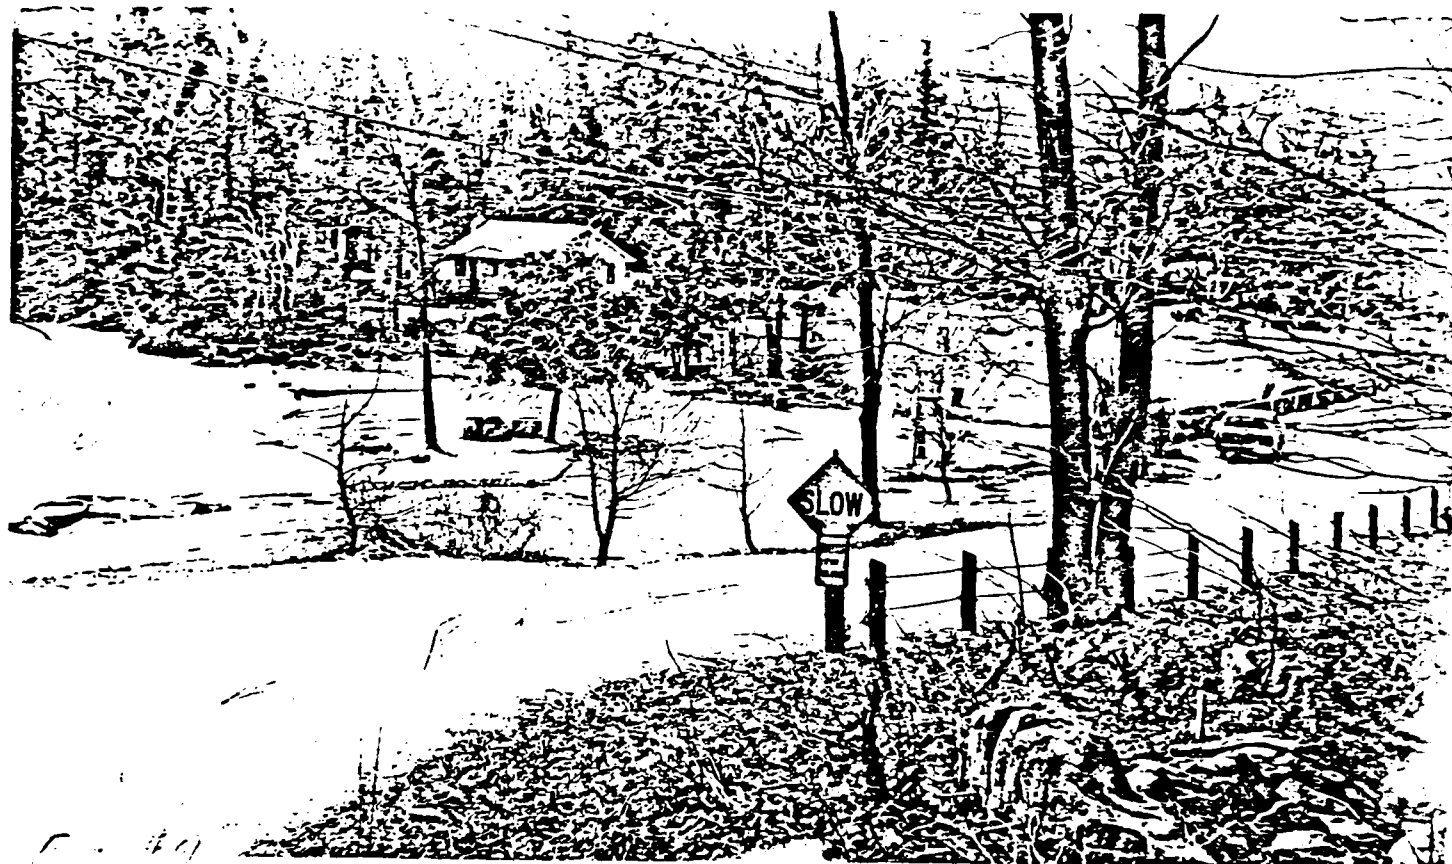
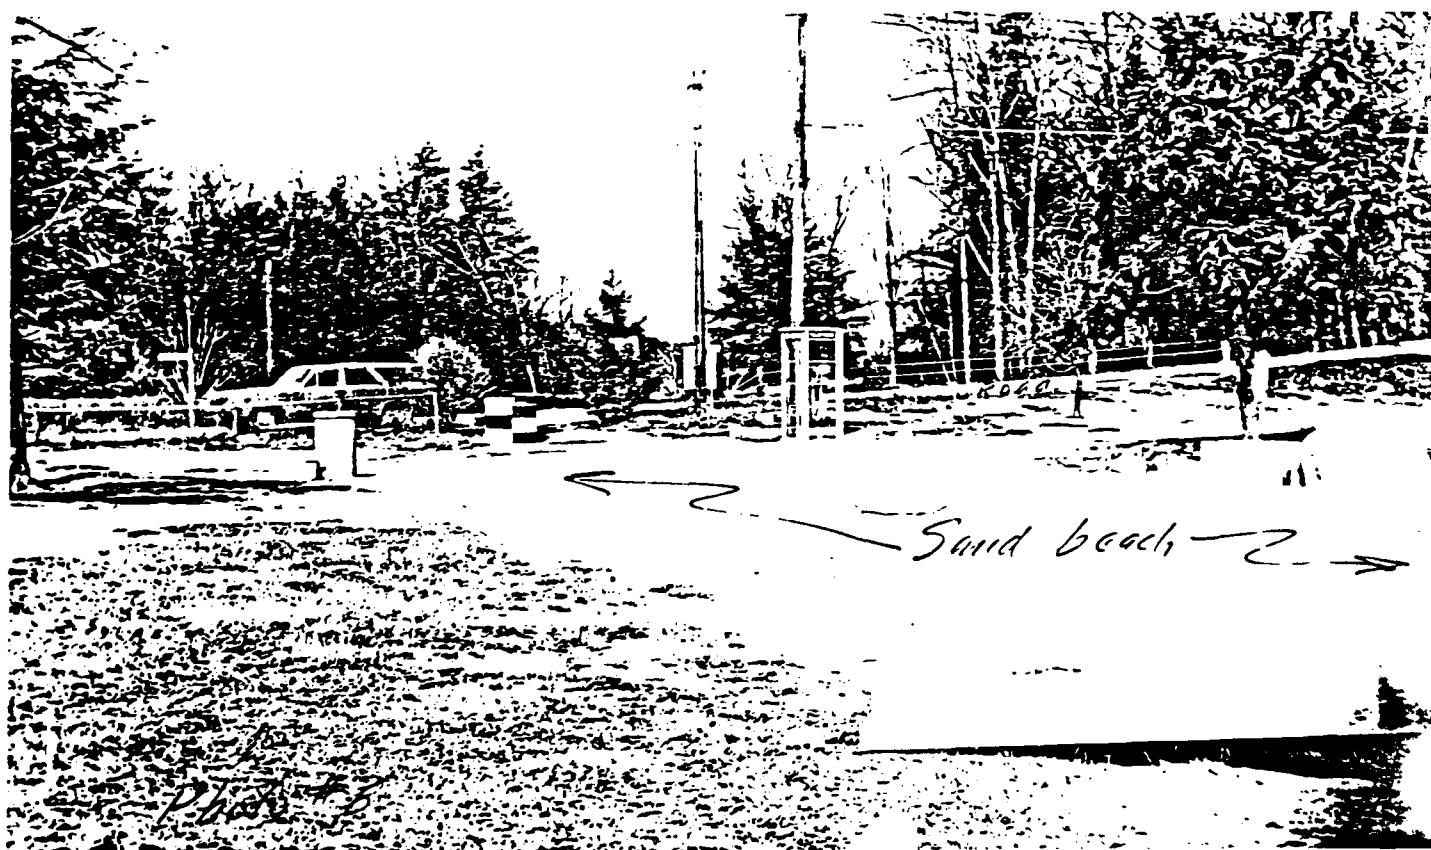
This photo shows some  
repaire to E. side dike as  
that shown in #13. Looking  
from road, over dike, Lake  
background.

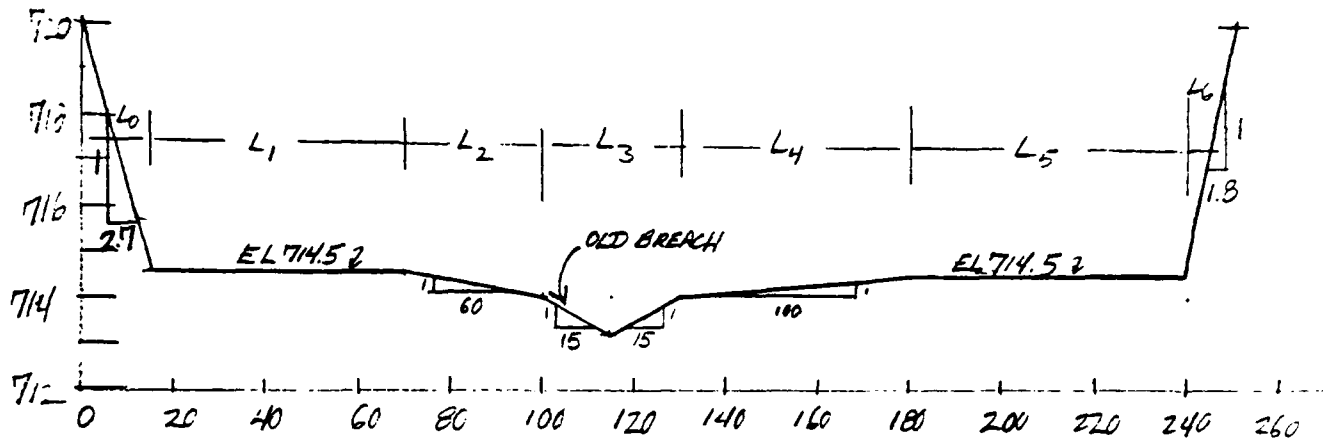
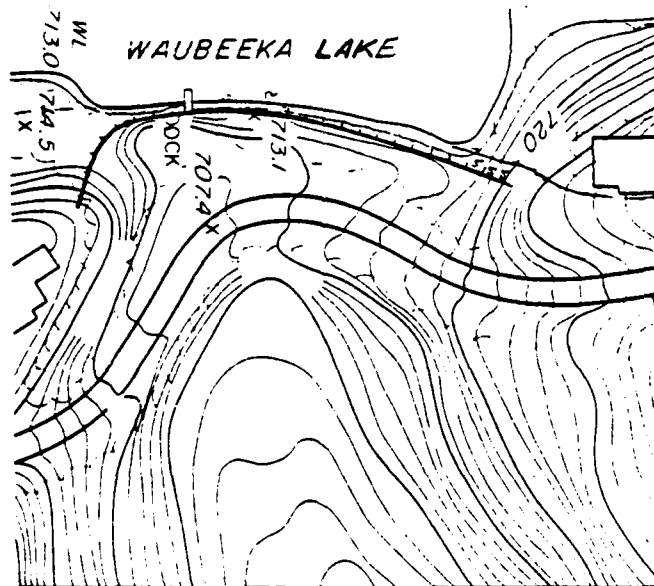
PROFILE ALONG  $\frac{1}{2}$  OF EAST DIKE ESTABLISHED FROM DANBURY TOWN  
TOPOGRAPHY,  $1"=100'$ , AND FIELD SURVEY MEASUREMENTS.

DISCHARGE CURVE FOR EAST DIKE: (ZERO FLOW AT EL 712, INVERT OF  
3" RCP UNDER WEST DIKE).
